PRE DRYWALL / FRAMING INSPECTION

1234 Main Street
Houston, TX 77099

06/17/2025 9:00AM

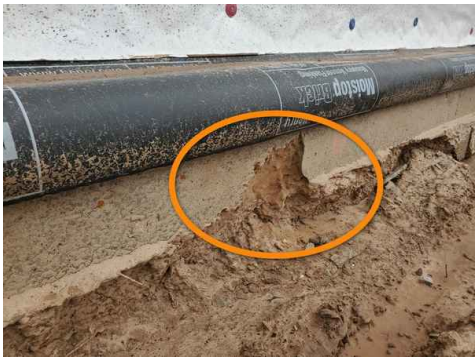
Left Side

2.1.1 Foundation, Basements, and Crawlspaces

SPALLING OR FLAKING
LEFT SIDE

Spalling or flaking occurring at the concrete slab. The builder should investigate further and repair as needed.

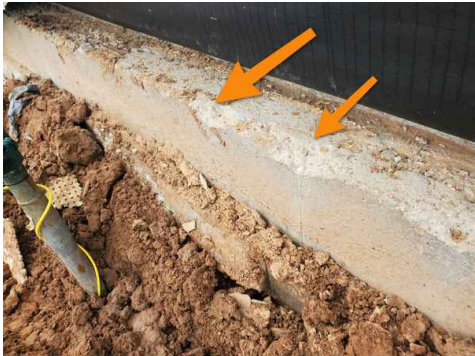
Right Side

2.1.2 Foundation, Basements, and Crawlspace

BRICK LEDGE: DAMAGED

Damage observed at brick ledge. Repair may be necessary to provide proper bearing of brick on brick ledge.

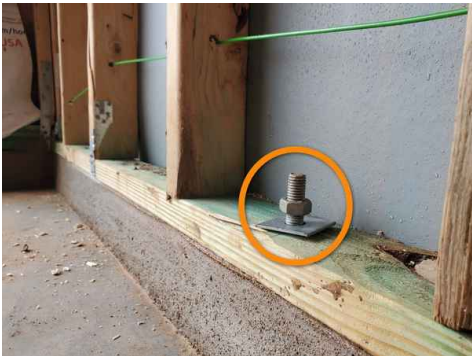
Garage

2.3.1 Walls (Structural)

ANCHORAGE/BOLTS: MISSING/LOOSE HARDWARE

Anchor / bolts missing nuts/washers. All anchor bolts should be secured with nuts and washers flush to the bottom plate.

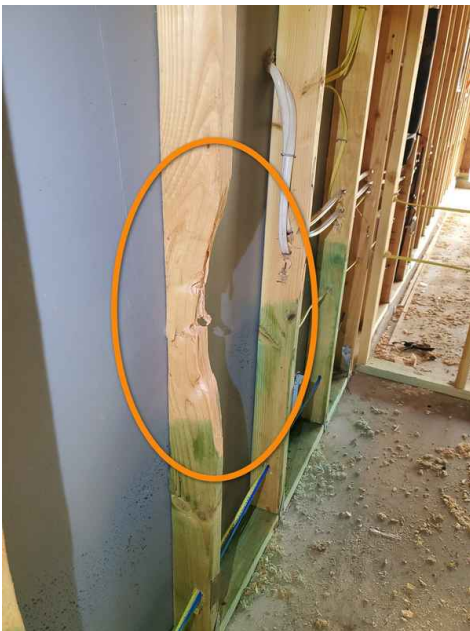
Right Side

2.3.2 Walls (Structural)

FRAMING: BOWED/TWISTED OR DAMAGED MEMBER(S)

Bowed/twisted or damaged framing members observed. Block or replace as necessary.

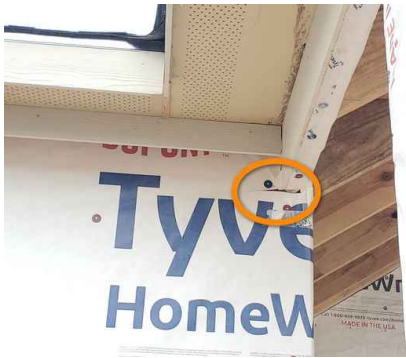
Rear (Tears/Holes)

2.4.1 Walls (Exterior Sheathing/Cladding)

SEAL EXTERIOR WALL PENETRATIONS

Tears/Holes, Plumbing Penetrations

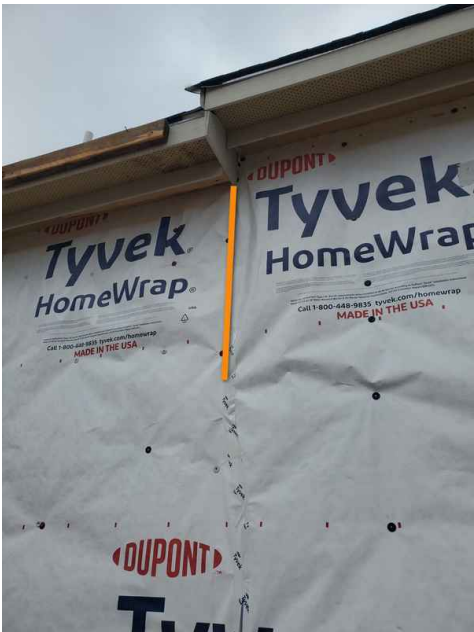
Left Side

SEAM TAPE IMPROPERLY INSTALLED: INCOMPLETE

The Tape was not complete or installed properly by overlapping as per installation requirements. We recommend to inspect complete and or replace.

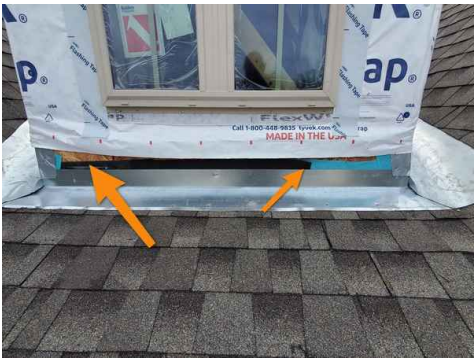
2nd Floor Front

TYVEK/OR WRB: MISSING

Observed missing Tyvek (or equivalent weather-resistive barrier) at [location, e.g., around window openings, at wall/roof intersections, over sheathing].

Proper installation is required.

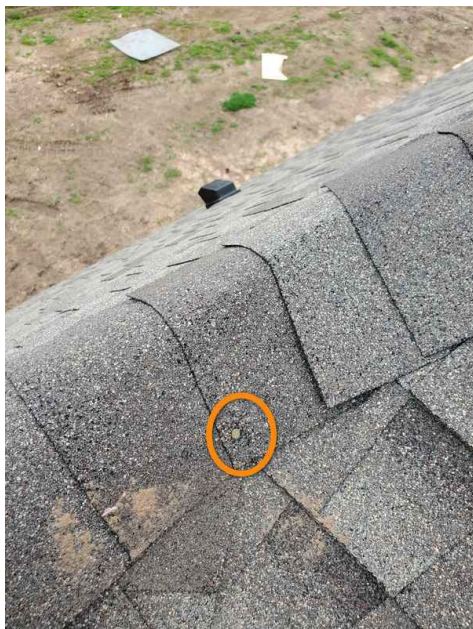
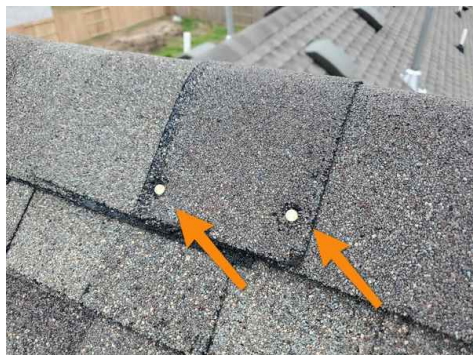
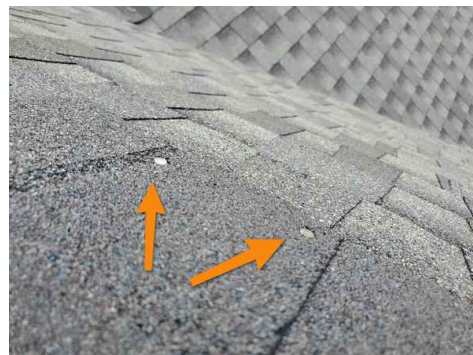
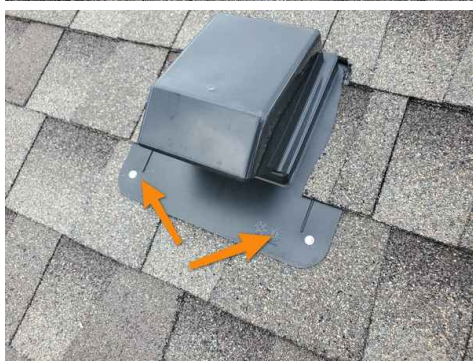
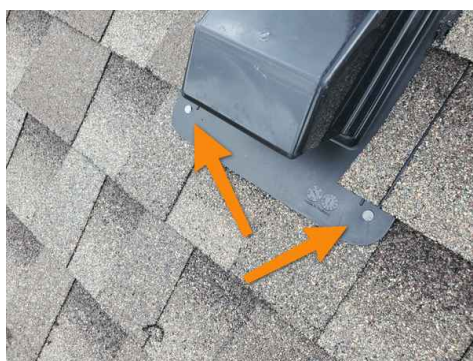
EXPOSED NAILS

There were Exposed Nails in the roofing shingles at the time of inspection. Each exposed nail can allow water to penetrate past the roof covering given enough time. As the exposed portion of the nail rusts, more space will become available between the nail and the roofing material for water to penetrate. Caulking/mastic should be applied to prevent the nails from rust and/or leaking. We recommend to caulk and repair as necessary.

Caulking as applied will need periodic maintenance to maintain integrity of the seal.

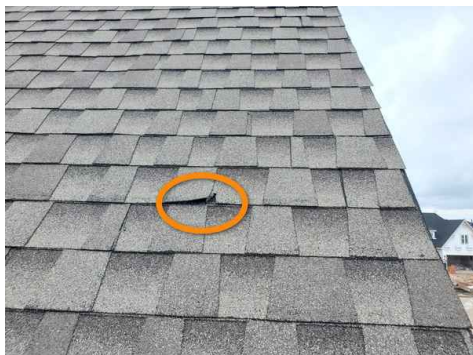
(Damaged)

MISSING/DAMAGED SHINGLES

Damaged and/or missing asphalt composition shingles were noted at the time of the inspection. We recommend to replace missing/damaged shingles to avoid damage to the underlying home structure from moisture intrusion.

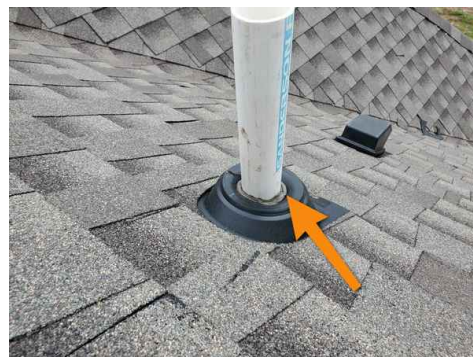
Inverted Neoprene Boot

CRACKED/DAMAGED OR INVERTED PLUMBING VENT BOOT

The boot for the plumbing vent is cracked/damaged or invisible neoprene boot should be fixed or replaced.

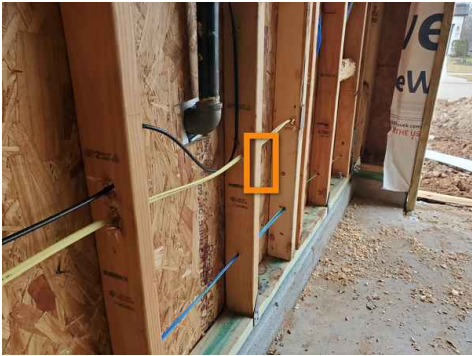
Garage

NAIL PROTECTION PLATES MISSING

Nail protection plates help prevent nails from piercing pipes and electrical lines after the drywall is installed. Nail protection plates are typically installed over utilities that pass within 1.25-inches from the edge of the stud. Evaluate and remedy as needed.

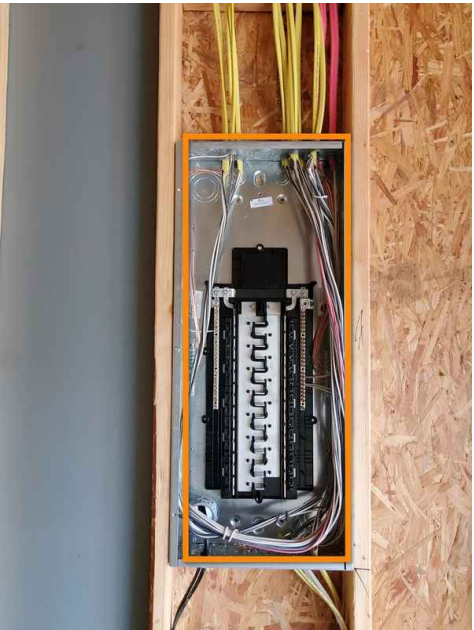
ELECTRICAL DISTRIBUTION PANEL

The electrical box is currently uncovered. This is a safety hazard and must be addressed. A proper cover plate must be installed.

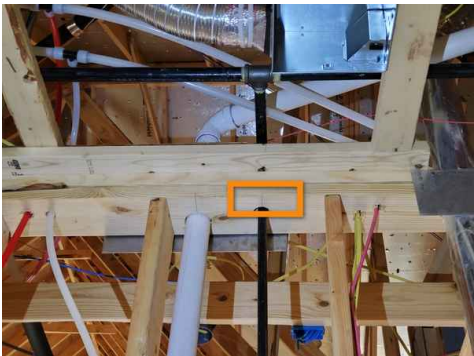
Laundry Area

NAIL PROTECTION PLATES MISSING

Nail protection plates help prevent nails from piercing pipes and electrical lines after the drywall is installed. Nail protection plates are typically installed over utilities that pass within 1.25-inches from the edge of the stud. Evaluate and remedy as needed.
