PRE DRYWALL / FRAMING INSPECTION

1234 Main Street
Houston, TX 77099

06/17/2025 9:00AM

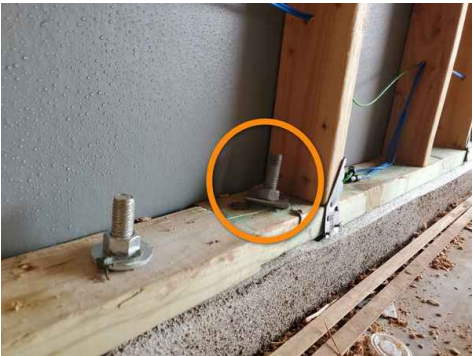
Garage

ANCHORAGE/BOLTS: MISSING/LOOSE HARDWARE

Anchor / bolts missing nuts/washers. All anchor bolts should be secured with nuts and washers flush to the bottom plate.

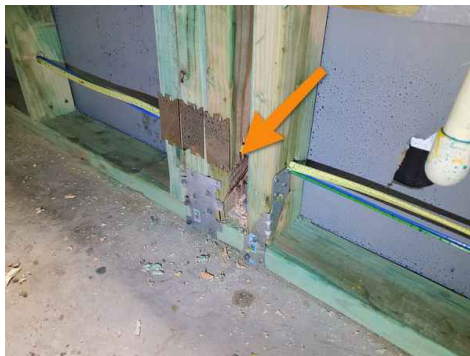
Right Side

FRAMING: BOWED/TWISTED OR DAMAGED MEMBER(S)

Bowed/twisted or damaged framing members observed. Block or replace as necessary.

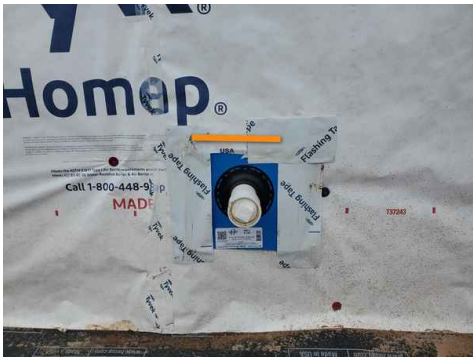
Left Side

SEAL EXTERIOR WALL PENETRATIONS

Tears/Holes, Plumbing Penetrations

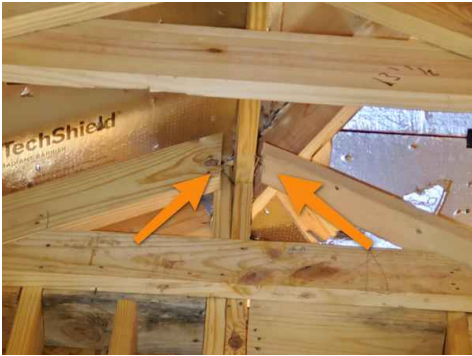
Living Room Rear

RAFTERS NOT CUT PROPERLY TO FIT FLUSH

Remedy as needed.

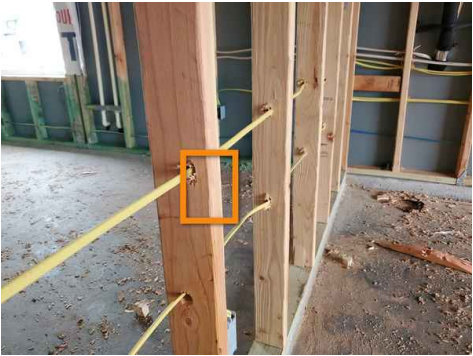
Garage

NAIL PROTECTION PLATES MISSING
